MAY 7, 1919

AN INVESTIGATION OF THE PROTECTIVE VALUES
OF STRUCTURAL STEEL PAINTS

By
J. S. COYE

BULLETIN 54
GOOD ROADS SECTION
ENGINEERING EXPERIMENT STATION

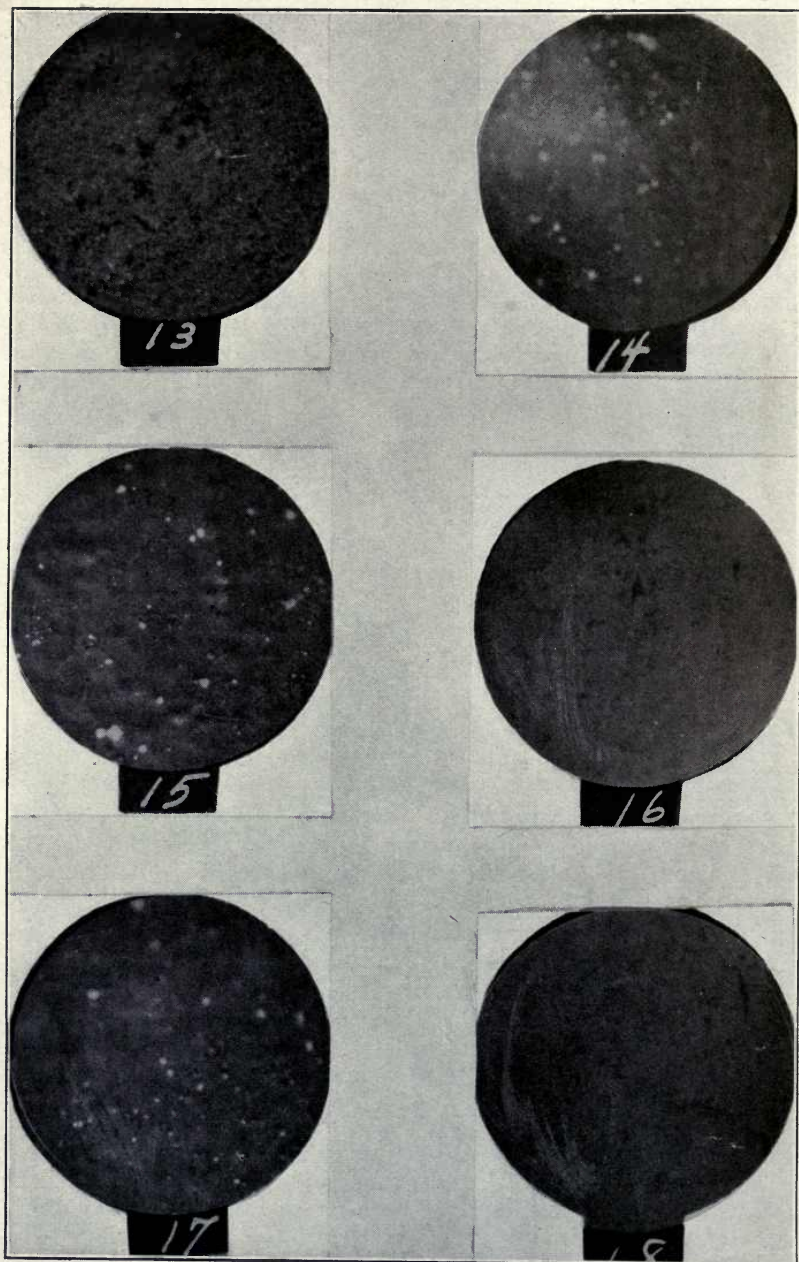
Microphotographs of Panels 13 to 18
Exposure about two years

Carbon paints are very serviceable and when properly and scientifically prepared produce a very elastic and impervious film. However, the results of these tests show that this class of paint should not be used as the first coat on metal, as rusting, altho delayed for several years, will begin beneath the paint film unless very careful attention is paid to keeping the surface repainted. As a field coat carbon paints are very valuable. See panels 1, 14, 17, 30, 36, 81, 108 and 134.

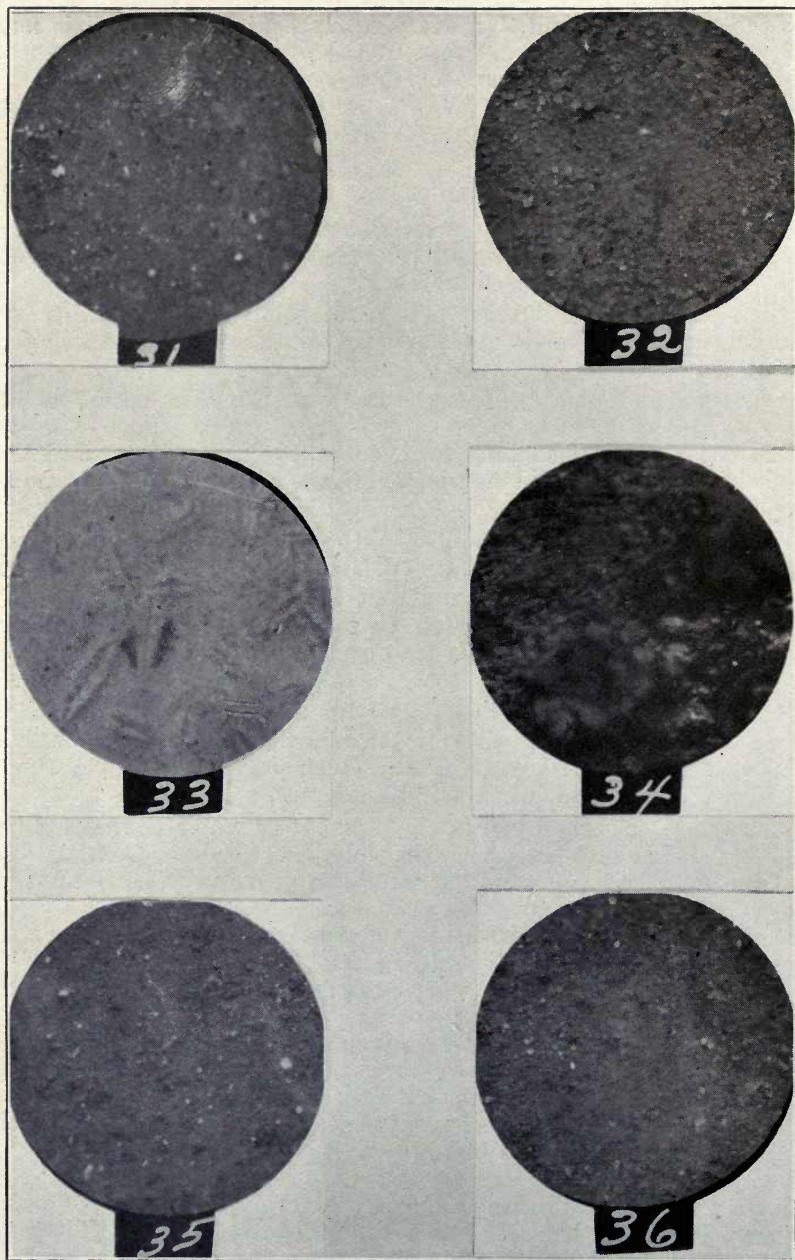
Microphotographs of Panels 31 to 36
Exposure about two years

Coal tar paints proved to be absolutely worthless as a steel coating. In every case they checked and alligatored badly and developed corrosion of the metal very early in the test. Furthermore, it is impossible to repaint over coal tar paint unless the same type of paint is used. Consequently, in order to repaint with a good oil paint it is necessary to burn and scrap off all old paint. This condition is enough in itself to exclude coal tar paints as a coating for steel structures exposed to the ordinary atmospheric agents. This type of paint does, however, serve admirably under some conditions where linseed oil paint would not hold up at all; namely for coating under ground pipes, warm smoke stacks, etc. Note panels 34, 129, 130 and 133 for this class of paint.

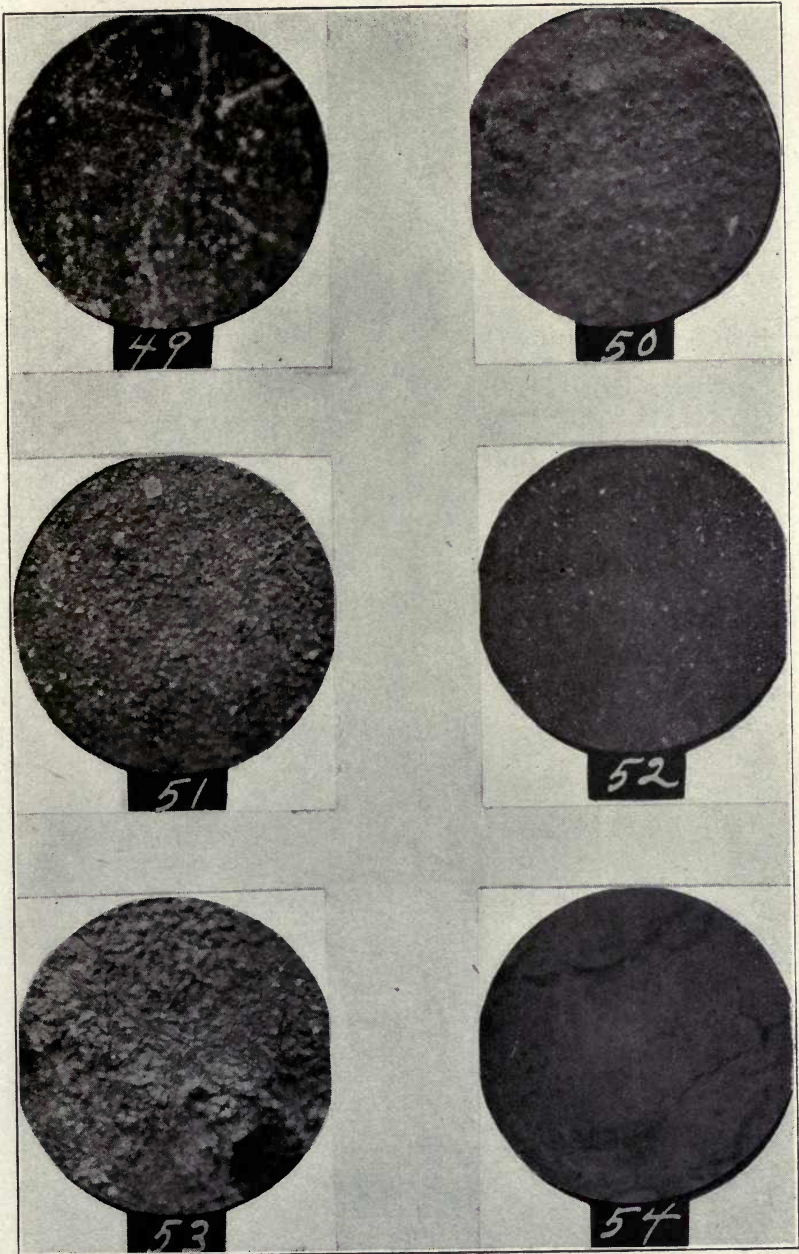
Microphotographs of Panels 49 to 54
Exposure about two years

Asphaltic base paints are similar to coal tar paints but do furnish considerable protection if properly made. Panels No. 1, 104 and 49 were coated with a paint containing an asphaltic base and are still giving good protection. However, panels 23, 124 and 125 coated with asphaltic base paints, have failed completely and must be burned, scraped and repainted. Gilsonite paint produces a brittle film which allows water to pass through to the metal; then corrosion proceeds rapidly.
